DEPARTMENT OF TRANSPORTATION**DIVISION OF ENGINEERING SERVICES**

Contract #: 04-0120F4Cty: SF/ALA Rte: 80 PM: 13.2/13.9File #: 69.28**WELDING INSPECTION REPORT****Resident Engineer:**Siegenthaler, Peter**Address:** 333 Burma Road**City:** Oakland, CA 94607**Report No:** WIR-022460**Date Inspected:** 12-Dec-2010**Project Name:** SAS Superstructure**OSM Arrival Time:** 700**Prime Contractor:** American Bridge/Fluor Enterprises, a JV**OSM Departure Time:** 1900**Contractor:** Zhenhua Port Machinery Company, Ltd (ZPMC), Changxing Island **Location:** Shanghai, China**CWI Name:** Qiu Wen**CWI Present:** Yes No**Inspected CWI report:** Yes No N/A**Rod Oven in Use:** Yes No N/A**Electrode to specification:** Yes No N/A**Weld Procedures Followed:** Yes No N/A**Qualified Welders:** Yes No N/A**Verified Joint Fit-up:** Yes No N/A**Approved Drawings:** Yes No N/A**Approved WPS:** Yes No N/A**Delayed / Cancelled:** Yes No N/A**Bridge No:** 34-0006**Component:** OBG**Summary of Items Observed:**

SEGMENT 13AW

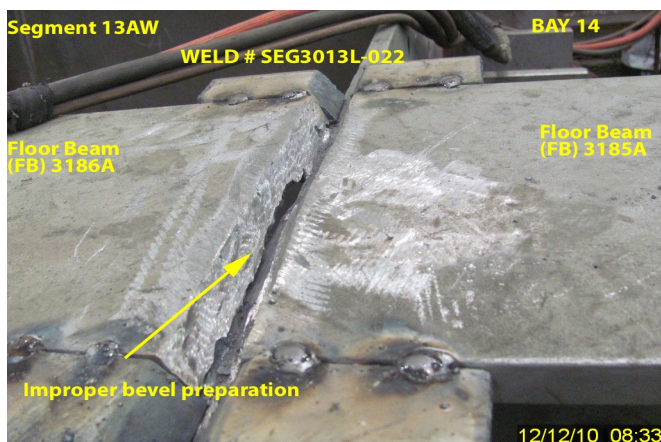
During random in process inspection this QA inspector observed the damaged bevel faces and excessive root gap between two floor beam flanges on the top of longitudinal diaphragm at Panel Point (PP) 119-1500. The weld number is identified as SEG3013L-022. The floor beams are identified as FB3185A and FB3186A at panel point (PP) 119-1500 of segment 13AW. The damaged bevel face was observed on the flange of Floor Beam (FB) 3186A. This issue has been discussed with ZPMC CWI Mr. Qiu Wen. ZPMC CWI Mr. Qiu Wen informed this QA that ZPMC will make welding repair report (WRR) for buttering on the bevel face and reduce the excessive root gap and smooth bevel face. Attached photographs provide additional details.
